USING INFRARED THERMOGRAPHY FOR STRUCTURAL INSPECTIONS

www.bldgdiagnostics.com

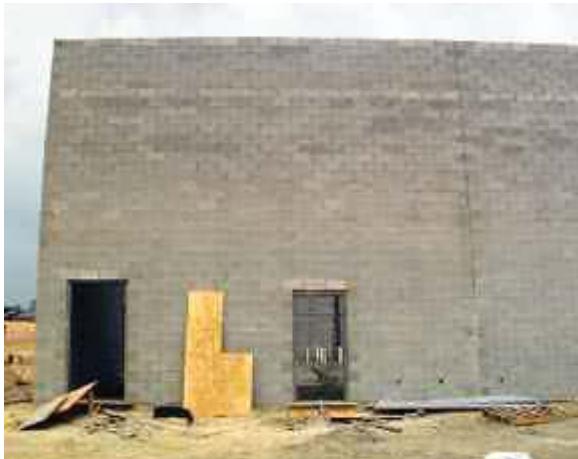
Figure 1
Typical CMU wall section

The infrared inspection of buildings for heat loss was one of the first commercial uses for infrared thermography. Another important use of IR is with the structural inspection of the walls of one type of building: CMU or concrete masonry unit. (See figures 1 and 2).

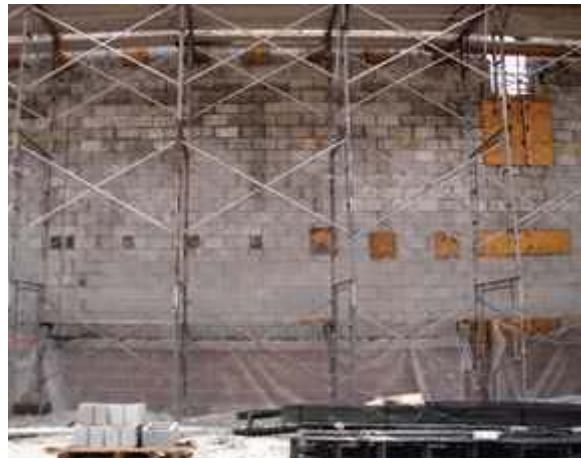
Figure 3 CMU wall section with inspection ports are time consuming and expensive.

Some buildings are effectively grouted, but it takes good inspection and quality workmanship. One method used in the past was to require the installation of inspection ports or holes, cut in the block faces. These are installed at every lift height and at all grouted vertical pilaster locations. (See figure 3.) This is a very costly, time-consuming and sloppy method. That is why infrared documentation can be so valuable. It is fast, inexpensive and accurate.
